DEPARTMENT OF TRANSPORTATION

Quality Assurance and Source Inspection

Contract #: 04-0120F4Cty: SF/ALA Rte: 80 PM: 13.2/13.9File #: 69.28**WELDING INSPECTION REPORT****Resident Engineer:**Pursell, Gary**Address:** 333 Burma Road**City:** Oakland, CA 94607**Report No:** WIR-016014**Date Inspected:** 02-Aug-2010**Project Name:** SAS Superstructure**OSM Arrival Time:** 700**Prime Contractor:** American Bridge/Fluor Enterprises, a JV**OSM Departure Time:** 1900**Contractor:** Zhenhua Port Machinery Company, Ltd (ZPMC), Changxing Island **Location:** Shanghai, China**CWI Name:** Mr. Xu Le Feng**CWI Present:** Yes No**Inspected CWI report:** Yes No N/A**Rod Oven in Use:** Yes No N/A**Electrode to specification:** Yes No N/A**Weld Procedures Followed:** Yes No N/A**Qualified Welders:** Yes No N/A**Verified Joint Fit-up:** Yes No N/A**Approved Drawings:** Yes No N/A**Approved WPS:** Yes No N/A**Delayed / Cancelled:** Yes No N/A**Bridge No:** 34-0006**Component:** Tower and Orthotropic Box Girder (OBG)**Summary of Items Observed:**

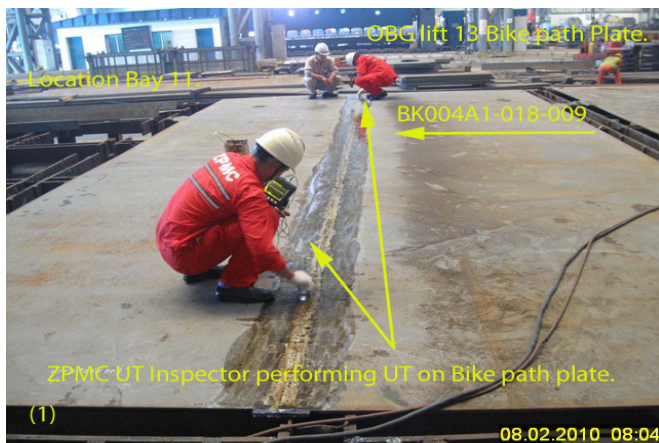
This QA Inspector observed ZPMC Ultrasonic Testing Inspector, performing UT on OBG lift 13 Bike path plate. Plate identified as BK004A1-018-009. For more information see below attached picture number 1.

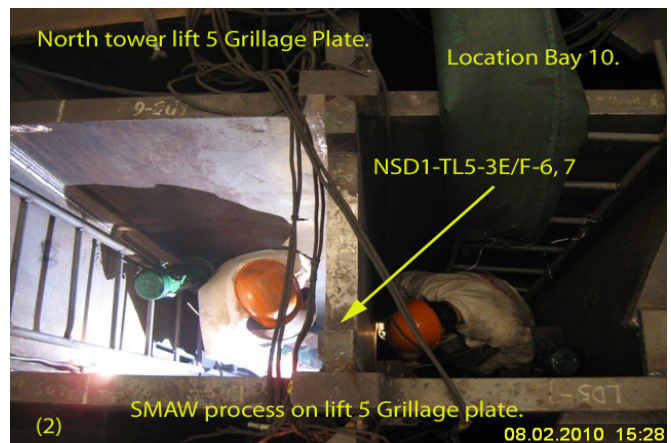
This QA Inspector observed ZPMC qualified welding personnel identified as 067707, 066443, 066115, 066326, Perform Shielded Metal Arc Welding (SMAW) on North Tower lift 5 Grillage plate. Joint identified as NSD1-TL5-3E/F-6, 7. ZPMC QC Identified as Fu Wei Min. The welding parameters as measured using QC's calibrated instrument appeared to be in general compliance with WPS-B-T-3313-Tc-P5. For more information see below attached picture number 2.
